15 Sample NTSB Reports Analyzed w/ the HFACS-ME Framework

HFACS-ME in Commercial Aviation

HFACS-ME Results of NTSB Reports

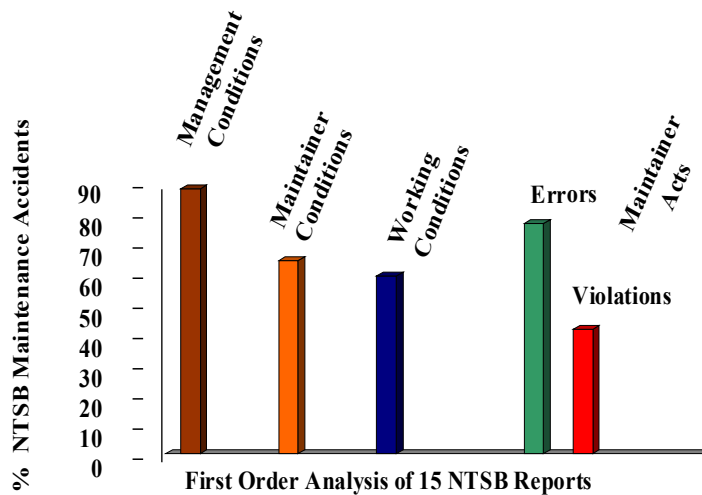
Results: The conditions observed include inadequate process, documentation, supervision, communications, and training. Consequently they contributed to errors in judgement, knowledge, and attention/memory as well as minor routine or isolated infractions.
